Lakehead Region  
Conservation Authority  
Conserve Today...For A Better Tomorrow

# MacKenzie River Watershed Assessment Report

## 2013

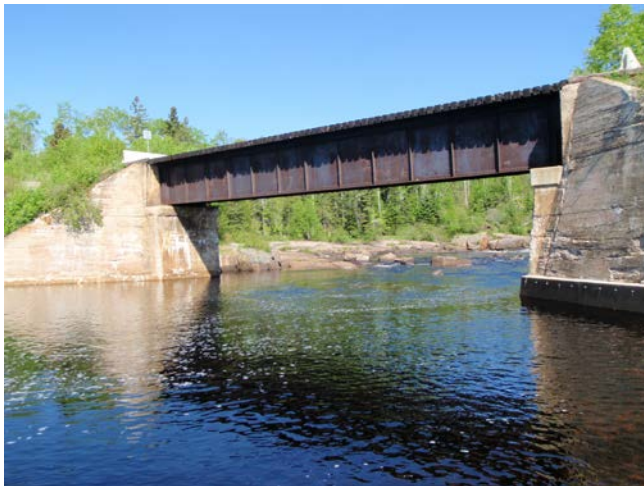
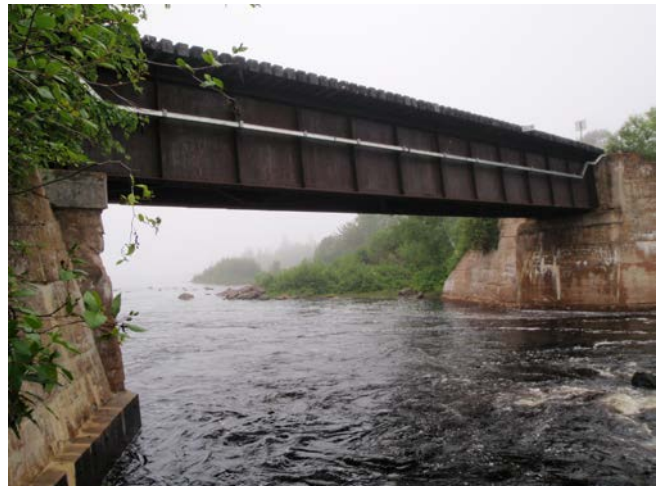
**Description:** This bridge is a decommissioned railway bridge owned by CN Railway; it was part of the Kinghorn railway. It can be accessed on either side by walking along the rail bed from Coral Beach Road or MacKenzie Beach Avenue. It is constructed of creosote timbers with a steel undercarriage and is private property prohibiting trespassing. The height of the bridge did not appear to alter natural channel characteristics. The width of the bridge appeared to cause interference when the concrete supports came into contact with the water on both sides, creating a narrower and deeper channel than what may have naturally been present. The high water mark was barely visible, and estimated to be 0.2 metres above the current level. There was visible stabilizing fill for this bridge on either side, consisting of boulder to gravel sized rip rap. The banks surrounding the bridge were fairly steep in order to maintain levelness with the raised railway bed. The banks were quite stable due to the large and heavy boulder rip rap holding it together.

The stream banks, primarily composed of bedrock and boulders, were stable and showed little to no signs of erosion. The water crossings appeared to be functional; however, Bridge 1, which is a decommissioned CN Railway bridge, should be monitored in the future as it is no longer in use and may begin to deteriorate, and Culvert 1, which is located on Crown land, had a buildup of woody debris and should be monitored during high water periods.

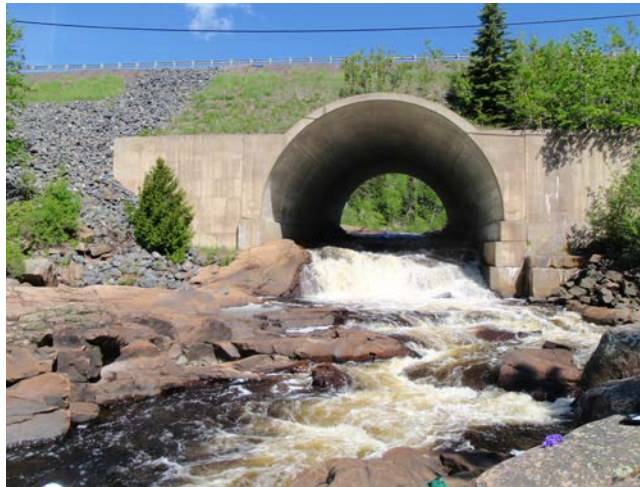
## Bridge 2

**Description:** This was a concrete culvert style bridge, the roadway has steel and wood guardrails installed. The base of the bridge is supported by granitic bedrock, which gives the bridge stability. The embankments from the highway down to the river are mostly grasses and shrubs, with a channel of riprap on either side of the bridge to filter out road runoff and prevent erosion. The bridge appeared to alter flow significantly, creating a narrower, smooth concrete channel allowing for very fast flow. Due to the high flow rate, bridge size and busy traffic, bridge measurements could not be done. A high water mark was not visible, but due to the lack of soil and vegetation present on the bedrock banks, it is possible that water runs much higher than the current level. Overall, the bridge was in good shape and will experience less traffic in the near future due to the construction of the divided highway twin bridges further upstream.

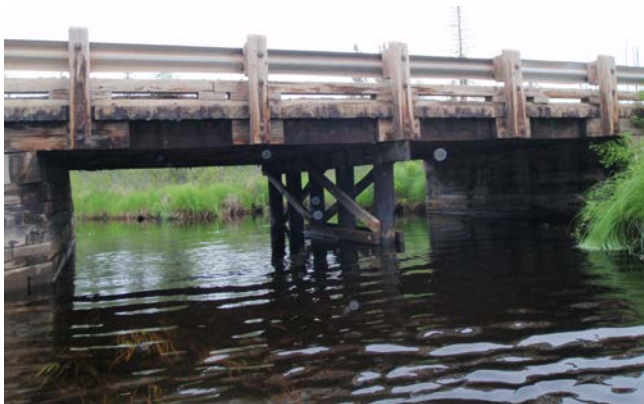
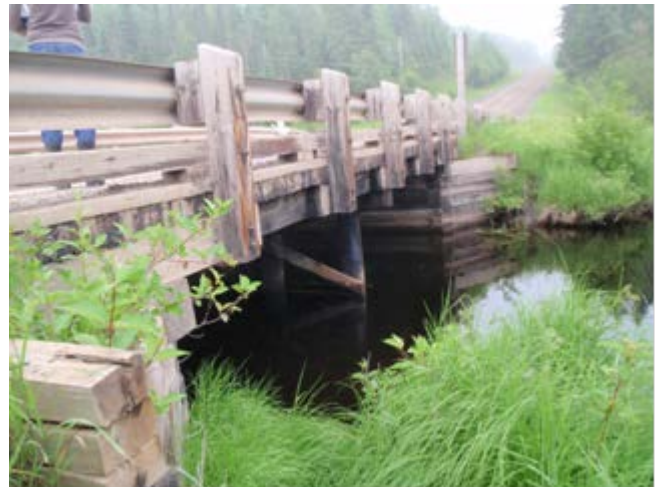
**Description:** This bridge was made of tar timbers and steel struts and included a metal guardrail on each side of the bridge supported by wooden posts. Large wooden cribs supported either side of the bridge. The substrate at the bridge is mostly cobble, with some gravel and sand, most likely from construction. The remainder of the creek, at the sample site, is mostly silt and muck with some gravel and sand. The bridge didn't appear to affect the flow rate since it was a fairly slow moving creek due to the low lying, flooded, wetland area where the bridge was situated, which forms a meandering channel downstream of the bridge. The high water mark could be seen on the cribs, 0.3 metres above the current level. The riverbanks from the bridge were well vegetated with graminoids and shrubs. The downstream banks were slightly undercut but no other evidence of erosion was present. The bridge was still in fairly good condition.

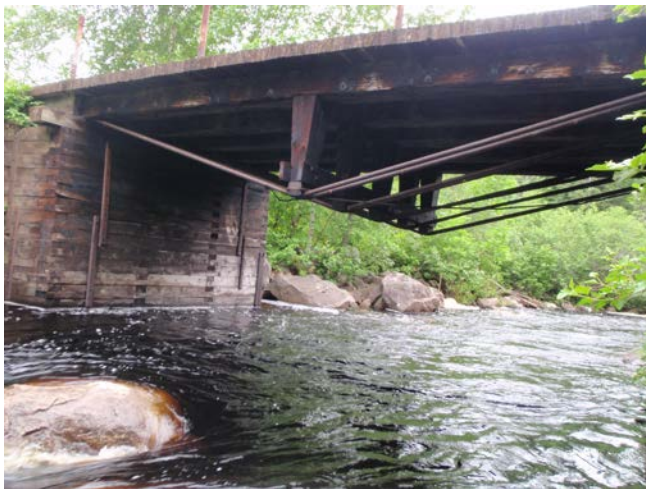
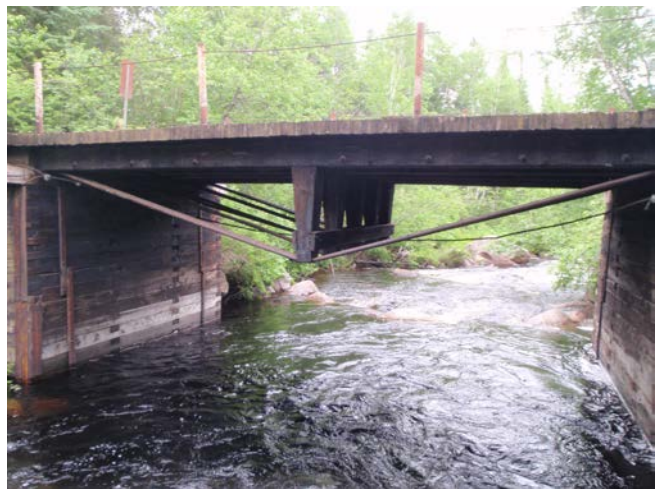
## Bridge 4

**Description:** This bridge was a wooden bridge with wooden cribs as supports on either side and a steel V-type support underneath. The bridge deck was wooden planks with residual asphalt evidence. There were steel posts with a cable side railing. The bridge did not appear to drastically affect the flow of water, however the cribs did protrude into the waterway by approximately 0.5 metres on either side, perhaps causing a narrower channel and increased flow rate. The high water mark (0.35 metres) was visible on the wooden cribs, however an emerging birch tree would indicate low water levels at some time, suggesting an extreme variation in the water level. The banks of the creek were boulder and bedrock which provided a stable base for the bridge and there was no evidence of erosion at the site.

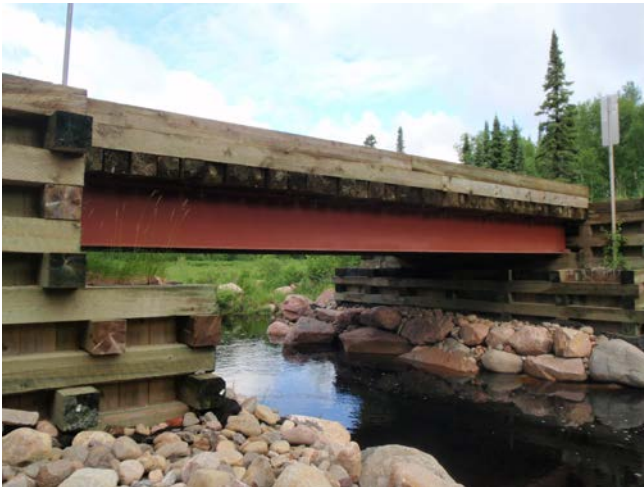
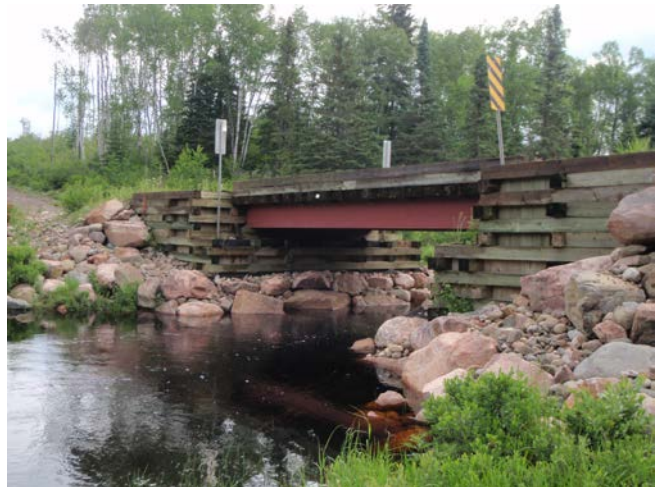
## Bridge 5

**Description:** This was a newer construction wooden bridge with a steel undercarriage and wooden planks on the deck. The wooden support cribs on either side of the bridge were filled in with cobble and gravel as well as geotextile cloth to filter runoff from the road. There were only wooden bumpers along the sides of the bridge with no guardrails or cables. The boulders and cobble at the site were largely from the bridge construction, creating a stable setting as well as erosion control banks leading down from the road. The cribs did not enter the water, however the boulders at the footings of the bridge may have narrowed the channel. When high water level was measured, the current level was above any possible mark due to heavy rains. The bridge was in a low-lying area with steep hills on either side. The bridge is in excellent condition and with regular use should remain in such condition

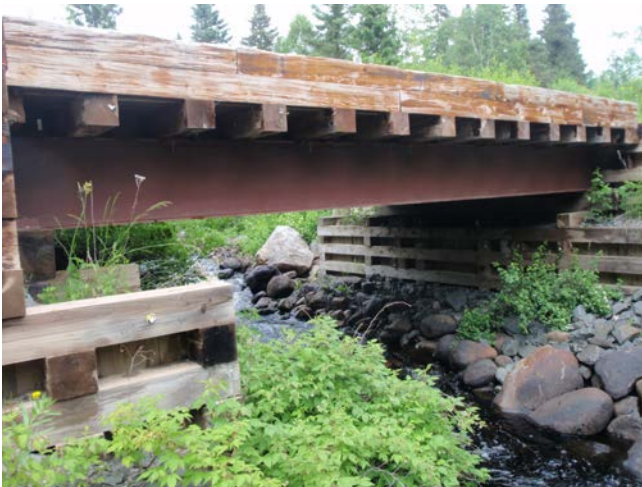
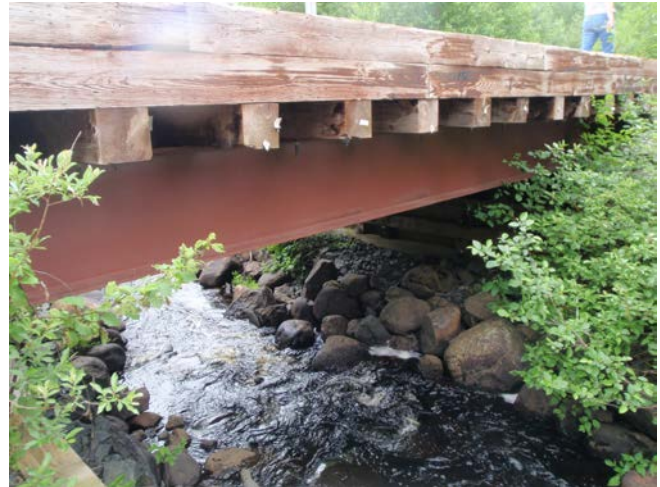
## Bridge 6

**Description:** This bridge was the same construction as bridge 5, although slightly older, made of wood beams with steel support beams underneath and wooden cribs on either bank filled with gravel and cobble. The deck of the bridge was made of wooden planks with shallow wooden bumpers along the sides. Boulder and cobble were used as a base for the two cribs for stability, which joined well with the natural stream bank and substrate also composed of boulders and cobble. The banks of the river were well vegetated with shrubs which provided excellent rooting for erosion control. A high water mark was not visible on the banks, but due to the lack of soil and vegetation it can be assumed that the water level has been higher than current conditions. The bridge did not interfere with water flow, and the channel width appears to be of natural course. The bridge was well maintained and in good condition.

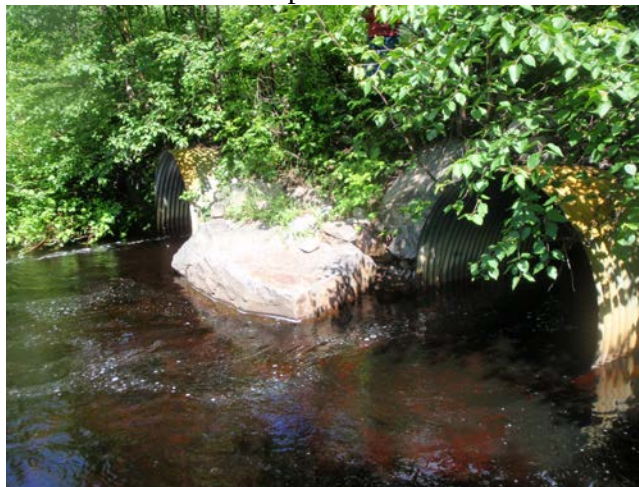
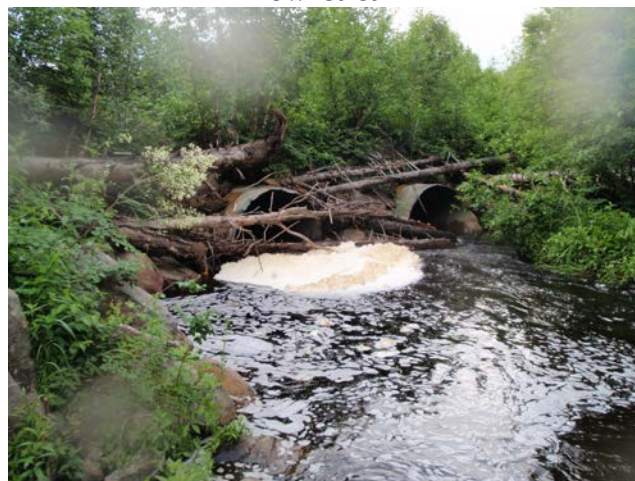
Description: This double culvert was located at “Amethyst creek”. They were firmly in place under the road, with boulders and dense vegetation growing around them on the roadsides. The flow rate was quite fast due to the small waterfall upstream. The culverts also had an effect on the creek, creating a narrower, smooth surface which increases velocity. The water level was filling approximately half of the culvert and the high water mark was 0.2 - 0.3 metres above the current water level. Therefore, there is no concern at the time for submerged culverts and road wash out due to high water levels. The culverts did however, have a buildup of woody debris and foam on the upstream end. This could restrict water flow through the culverts and cause flooding of the banks on one side of the road.

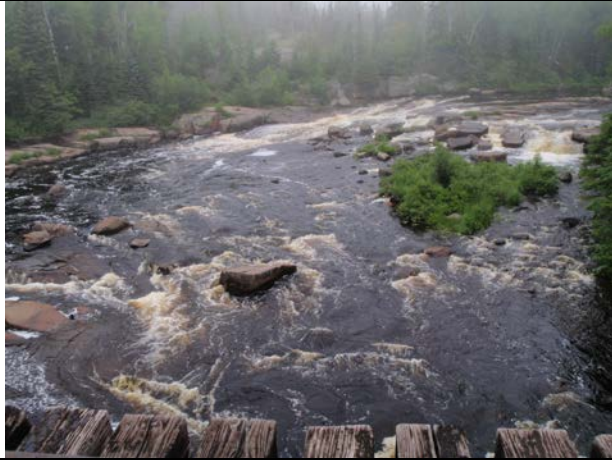
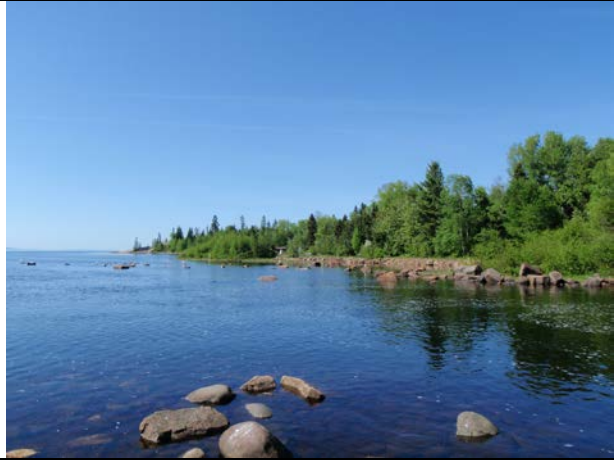
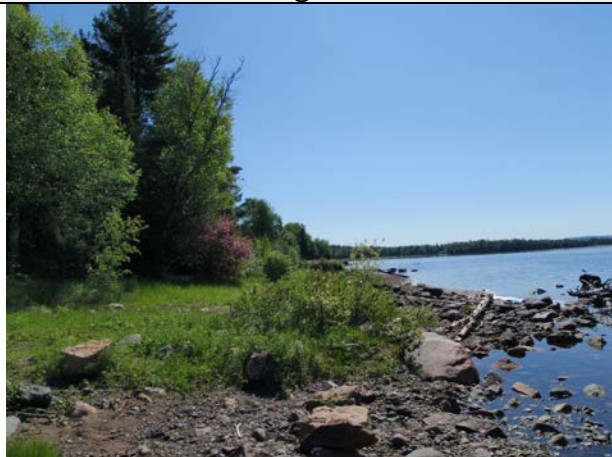
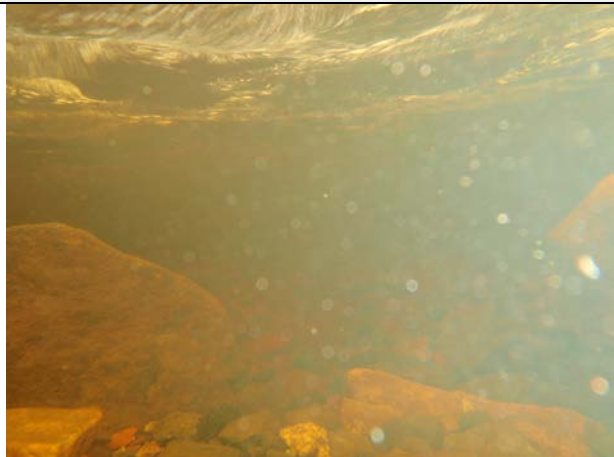
| Site 1 – Confluence of MacKenzie River, Decommissioned CN rail bridge | |

Sample Site 1 was located off of MacKenzie Beach Avenue and was chosen to represent the confluence of the MacKenzie River with Lake Superior. Access to the sampling site was along a footpath from the end of MacKenzie Beach Avenue. There is a decommissioned CN railway bridge at the site, which was part of the Kinghorn railway. Large boulders and cobbles were dominant within the river and the water was deep with very fast moving water from the rapids farther upstream. The banks of the confluence appeared stable and were vegetated further back from the water with shrub, herb and grass growth on sandy loam soil. No erosion was apparent along the banks of the channel or the steep slopes leading up to the rail bridge. During the June sampling period many Herring Gulls were congregating around the mouth of the river at the sampling site.

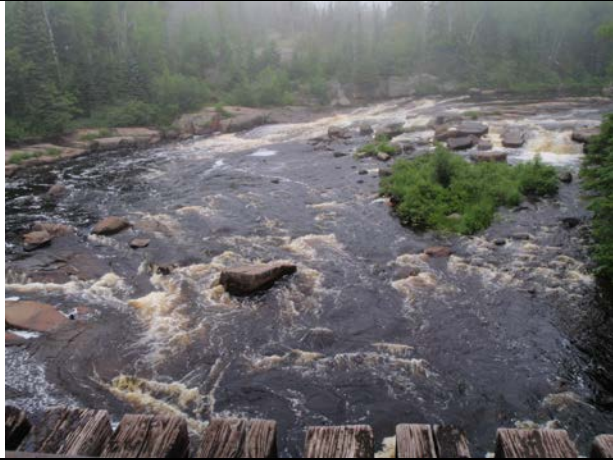
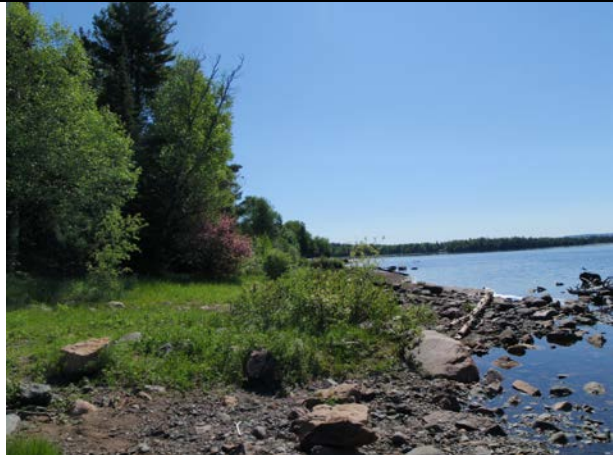
| Site 1 – Confluence of MacKenzie River, Decommissioned CN rail bridge | |

Sample Site 1 was located off of MacKenzie Beach Avenue and was chosen to represent the confluence of the MacKenzie River with Lake Superior. Access to the sampling site was along a footpath from the end of MacKenzie Beach Avenue. There is a decommissioned CN railway bridge at the site, which was part of the Kinghorn railway. Large boulders and cobbles were dominant within the river and the water was deep with very fast moving water from the rapids farther upstream. The banks of the confluence appeared stable and were vegetated further back from the water with shrub, herb and grass growth on sandy loam soil. No erosion was apparent along the banks of the channel or the steep slopes leading up to the rail bridge. During the June sampling period many Herring Gulls were congregating around the mouth of the river at the sampling site.

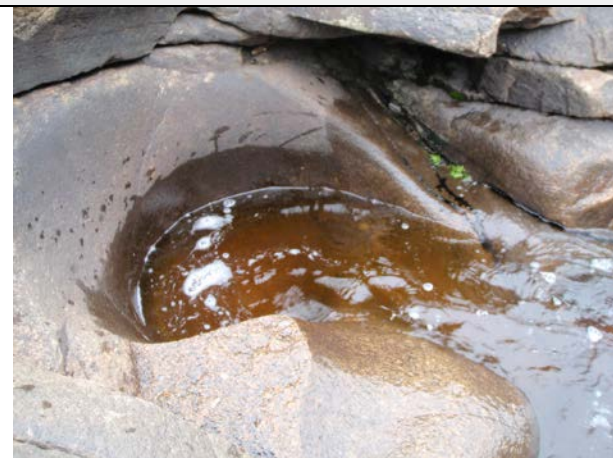
**C: Substrate Photo**

Sample Site 2 was located on MacKenzie Beach Road south of the Highway 11/17 bridge crossing, and was characterized by a large cement bridge with highway traffic crossing it. The water was very fast moving with a stained tea colour. The dominant substrate observed was bedrock, away from the river, the soil type was found to be shallow-moderately deep sandy. There was no evidence of erosion of the boulder and bedrock banks and the forest soil did not appear to be eroding. There was little to no aquatic vegetation observed at this site as water was moving very fast through the cement bridge and bedrock channel. The river had varying widths, which altered the flow rate greatly from one spot to the next. The only vegetation present on the banks of the river was crusty algae, some grasses and herbs. Further back from the river bank, shrubs such as shrubby cinquefoil and high bush cranberry and herbs begin to grow, leading into the forest where mature trees such as white birch, white spruce and balsam fir could be found.

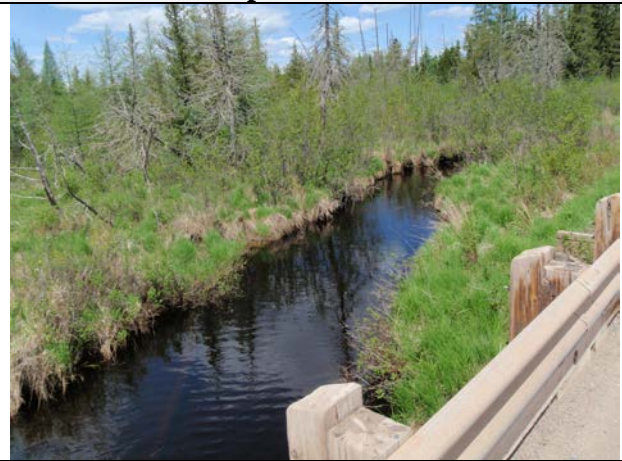
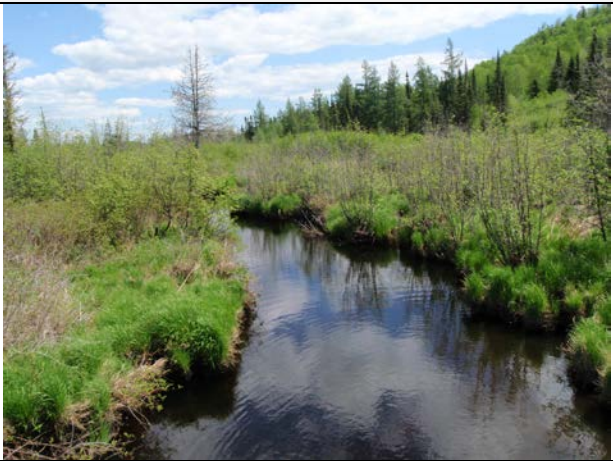
| Site 3 – MacKenzie Creek on MacKenzie Station Road | |

Site 3 was located on MacKenzie Station Road south of Walkinshaw Road and was characterized by its low-lying wetland appearance. The main channel flows southeast (seen in photo A: Upstream), while a second channel flows from a low-lying wetland area into the main channel at the bridge location. The water was quite shallow and slow moving at the sample site, with a wide channel at the convergence of the two branches, and narrow farther upstream and downstream. The site was a low-lying area with vegetation typical of a treed bog wetland. The banks were mainly composed of shrubby/grassy hummocks both up and down stream, and gravelly sand near the roadside. The streambed substrate was mostly cobble and gravel with some coarse sand. There was no evidence of erosion since the banks were mainly composed of well conglomerated roots and organic soil, and the flow rate is not fast enough to carry the heavy substrate present. The creek contained submerged and floating leaved aquatic vegetation, including tape celery and Richardson's pondweed. A garter snake was observed on the banks at this site. A railway crossing is located approximately 300 metres upstream.

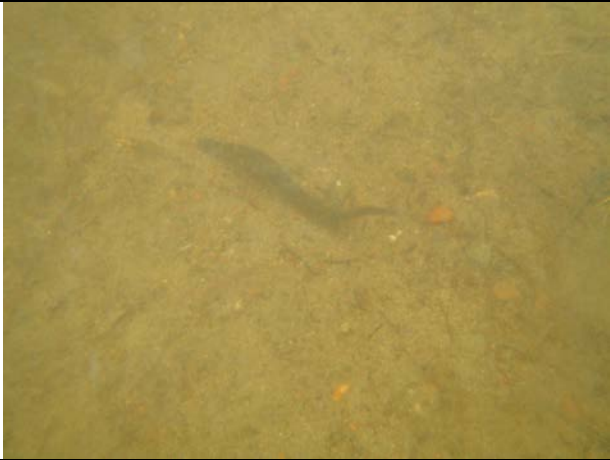
| Site 4 – Sparks Lake, MacKenzie Station Road (Private Property) | |
|---|---|
| C: Substrate Photo | |

Site 4 was located on private residential property on Sparks Lake, off MacKenzie Station Road. The site was characterized by densely vegetated marsh type shorelines with cattail and sedges on either side of the mowed grass lawn. Other aquatic plants found at the site included common bladderwort, flat-stemmed pondweed and three-seeded sedge. The lakeshore was predominantly black spruce and tamarack transitioning to black spruce and jack pine moving upland. The water at this site was stained and is a relatively shallow lake, with a sandy muck bottom. The velocity was not measureable due to wind effect and non-flowing lake water. There were many Red-winged blackbirds present at the sample site during the June site visit, with a nest observed for one mating pair. There was an abundance of Canada goose feathers and scat during the July site visit, indicating their presence. The site also had the most diverse benthic community observed among all the sample sites including freshwater leeches (in photo C above), freshwater clams, water striders, and water boatmen.

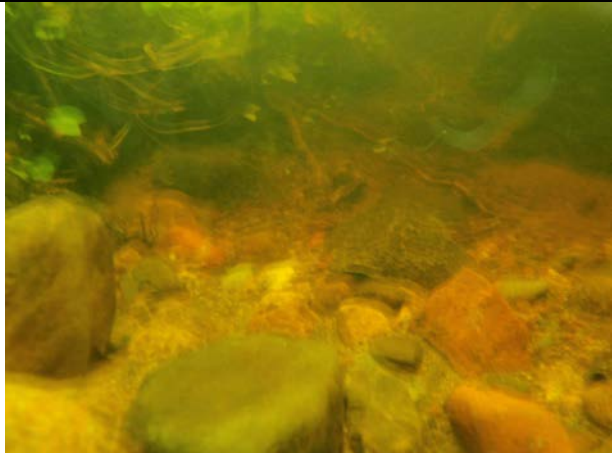
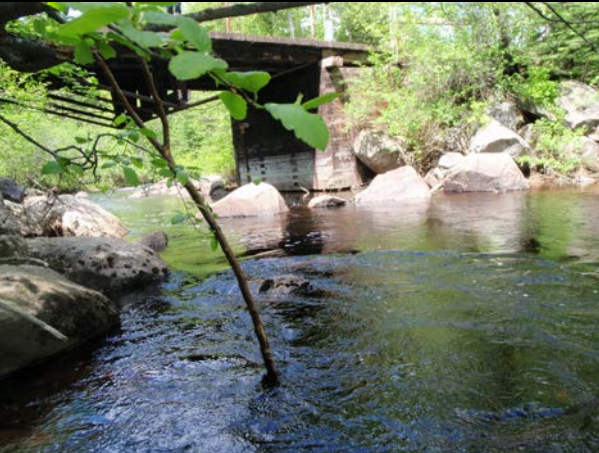
| Site 5 – Walkinshaw Creek crossing on Walkinshaw Road | |
|---|---|
| C: Substrate Photo | D: Emergent white birch (varying water levels) |

Site 5 was located on Walkinshaw Creek at the Walkinshaw Road bridge crossing, east of MacKenzie Station Road. The creek demonstrated a perfect riffle, run, pool sequence. The water was flowing at a quick pace during both site visits. The banks were stable and showed no sign of erosion. The stream substrate was mostly boulders and cobble, with some gravel and sand filling the pore space. There was little to no aquatic vegetation observed at the site. Terrestrial vegetation could be seen emerging from the creek, including a young white birch tree, indicating high water levels. Stream cover (40 percent) was provided by the densely growing shrubs and trees on the creek banks. A cabin is located approximately 100 metres upstream.

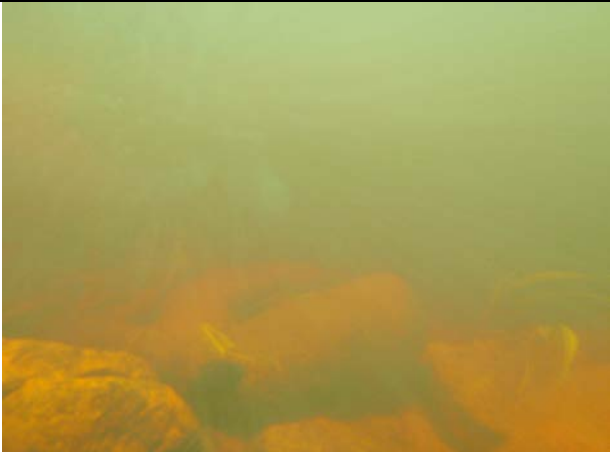
| Site 6 – Magone Lake outlet, Magone Road | |
|---|---|
| C: Aquatic Vegetation Photo | |

Site 6 was located at the Magone Lake outlet, east of Magone Lake on Kingfisher Road. The water crossing was located on Kingfisher Road approximately 600 meters off Magone Road, connecting to Highway 527. The water was very shallow and slow moving during the June site visit. During the July site visit, there was a significant increase in the water level from heavy rains, flooding the streambed that was bare rock during June. This caused the exact sample location to be unreachable and was moved closer to the bridge. There was no substantial erosion occurring at the site, however minor movement of sand may have occurred with the high water. The site was located in a valley between two large hills, creating a wetland area upstream of the bridge. Downstream the creek becomes narrow and picks up velocity as it travels over the rocky channel. Boulders and cobble were the dominant substrate with aquatic vegetation growing in the sand between them. The dominant vegetation observed in the lowland area was sweet gale, fragrant white lily, broad-leaved arrowhead and a variety of graminoids. A red-tailed hawk was observed here during the July visit. The stream cover (20 percent) was provided by the vegetation growing right to the water's edge.

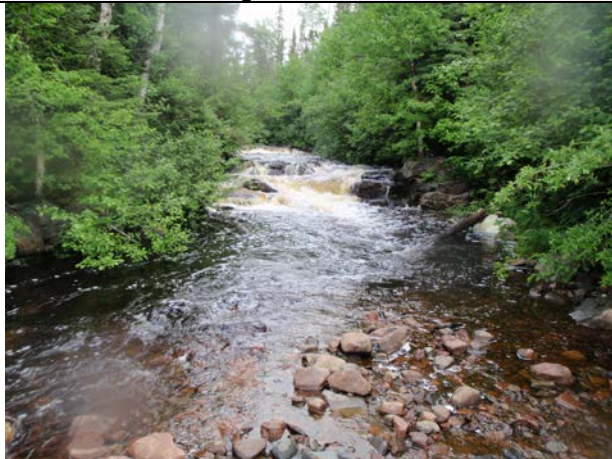
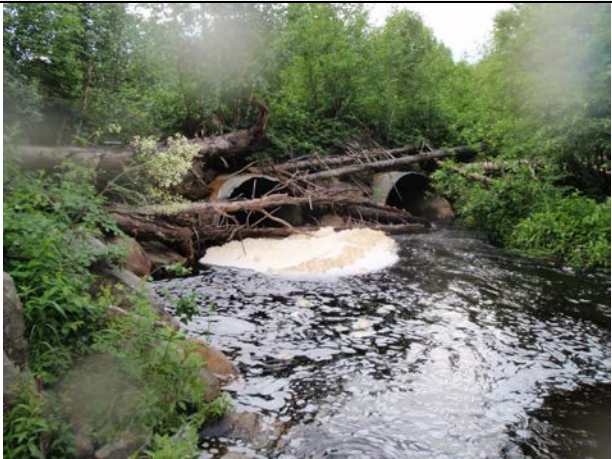
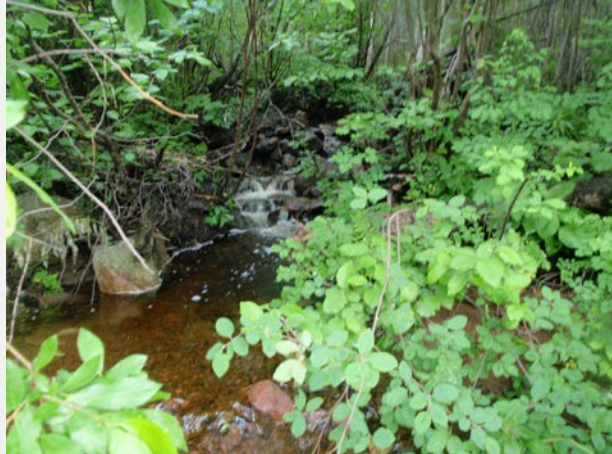
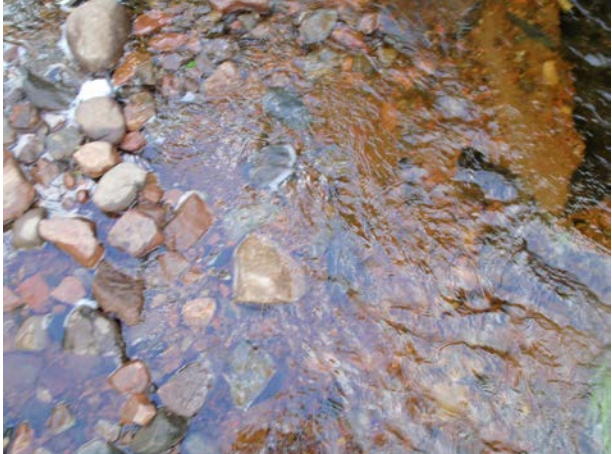
| Site 7 – Magone Road, “Amethyst Creek” | | | |

Site 7 was located on Magone Road at “Amethyst Creek”, 8.5 kilometers east of Highway 527. The samples were taken upstream of the road crossing due to accessibility. Upstream on the east bank, there is a significant amethyst vein in the bedrock, giving the creek its unofficial name, “Amethyst Creek”. There is evidence of harvesting of the gemstone here. A secondary stream was entering the creek from the east bank, which originates at a beaver pond approximately one kilometre away. This site had two culverts installed underneath the road. The flow rate was quite fast due to the waterfall upstream. There was no bank erosion observed, however the smaller substrate particles may experience movement during high water levels. There was some stream cover (40 percent) from thick shrubbery growing out over the stream, as well as mature trees growing on the banks of the river. Some commonly observed plants include white birch, black spruce, pin cherry, speckled alder, bunch berry and honeysuckle. There was a small island of cobble and gravel, the dominant creek substrate, which is where surface water samples were taken from. Black bear, fox, mink and ruffed grouse were seen in the area in July. A fire pit was located at the site as well, indicating hunters or fishermen.

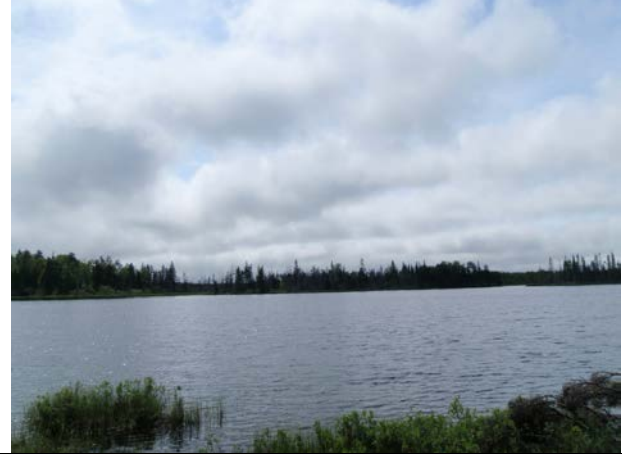
| Site 10 – Beaver Lake, Greenwich Wind Farm, Organized Township of Dorion | |

Site 10 was located within the Greenwich Wind Farm property on the north shoreline of Beaver Lake. The sample site is reached via Ouimet Canyon Road and Road N within the wind farm property. The sample site was accessed through the bush approximately 40 metres from a gravel parking spot. The substrate of the lake was very mucky and released a sulfur smell when disturbed. Aquatic vegetation was abundant at the sample site with fragrant white lily, water shield, graminoids and pondweeds as well as sweet gale and leatherleaf on floating mats. The forest soil type was a fresh, fine loamy soil supporting dominant vegetation species black spruce, eastern white cedar, balsam fir, white birch, wild raspberry and blue bead lily. The water was very stagnant and was tea colour stained. There were many minnows observed during the July site visit. A moose, white-tailed deer, a groundhog, a black bear and an american kestrel were sighted on the way to the site.

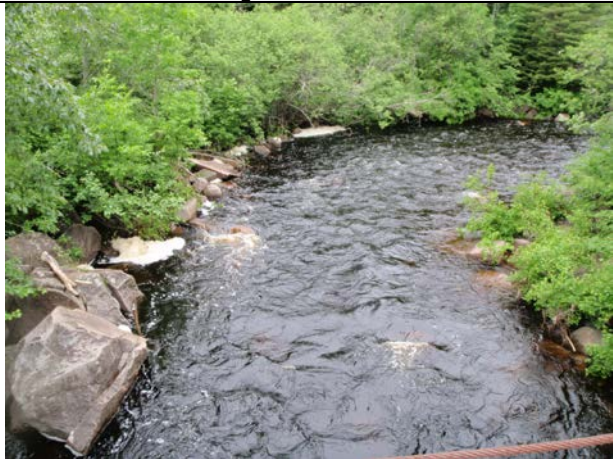
| Site 5 – Walkinshaw Creek crossing on Walkinshaw Road | |
|---|---|
| A: Upstream Photo | B: Downstream Photo |

Site 5 was located on Walkinshaw Creek at the Walkinshaw Road bridge crossing, east of MacKenzie Station Road. The creek demonstrated a perfect riffle, run, pool sequence. The water was flowing at a quick pace during both site visits. The banks were stable and showed no sign of erosion. The stream substrate was mostly boulders and cobble, with some gravel and sand filling the pore space. There was little to no aquatic vegetation observed at the site. Terrestrial vegetation could be seen emerging from the creek, including a young white birch tree, indicating high water levels. Stream cover (40 percent) was provided by the densely growing shrubs and trees on the creek banks. A cabin is located approximately 100 metres upstream.

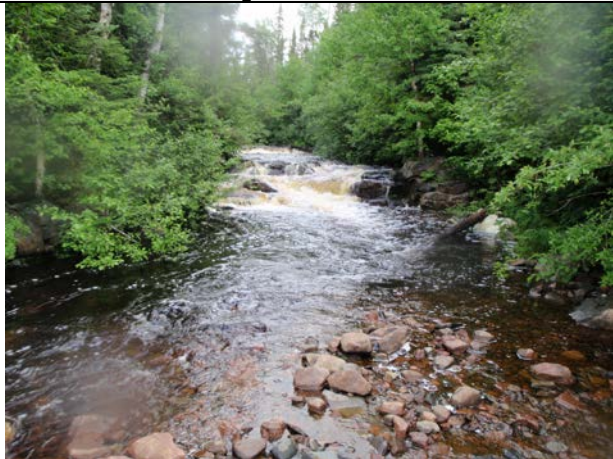
| Site 7 – Magone Road, “Amethyst Creek” | | | |
|---|--|---|--|
| A: Upstream Photo | | B: Downstream Photo | |

Site 7 was located on Magone Road at “Amethyst Creek”, 8.5 kilometers east of Highway 527. The samples were taken upstream of the road crossing due to accessibility. Upstream on the east bank, there is a significant amethyst vein in the bedrock, giving the creek its unofficial name, “Amethyst Creek”. There is evidence of harvesting of the gemstone here. A secondary stream was entering the creek from the east bank, which originates at a beaver pond approximately one kilometre away. This site had two culverts installed underneath the road. The flow rate was quite fast due to the waterfall upstream. There was no bank erosion observed, however the smaller substrate particles may experience movement during high water levels. There was some stream cover (40 percent) from thick shrubbery growing out over the stream, as well as mature trees growing on the banks of the river. Some commonly observed plants include white birch, black spruce, pin cherry, speckled alder, bunch berry and honeysuckle. There was a small island of cobble and gravel, the dominant creek substrate, which is where surface water samples were taken from. Black bear, fox, mink and ruffed grouse were seen in the area in July. A fire pit was located at the site as well, indicating hunters or fishermen.
